Refreshing the Turk's Interior

by Doug Bailey, member '58 Cadillac Owners' Club (*right*)

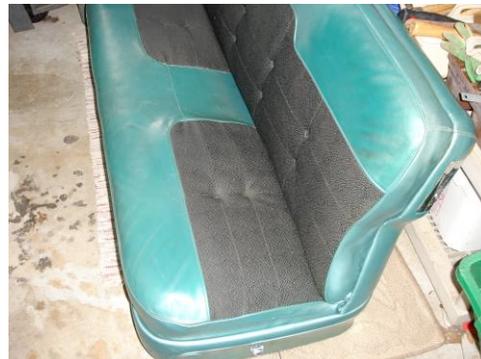
The seats: The front seat came out with four ½" bolts on each side. Bolts and brackets went straight into labeled baggies, because it was two months before they would go back in. My son and I lugged the seat to Denny's workshop. It is a beast... Denny fabricated two new springs, installed new foam cushioning and re-sewed the

separated seams on the corners. Miraculously, he made the ripped seam in the middle of the vinyl upholstery disappear. The \$375 Denny charged me was a bargain; no way I could have done this. I installed a new ground line for the cigar lighter then put the seat aside for later. The back seat was good to go, as is.

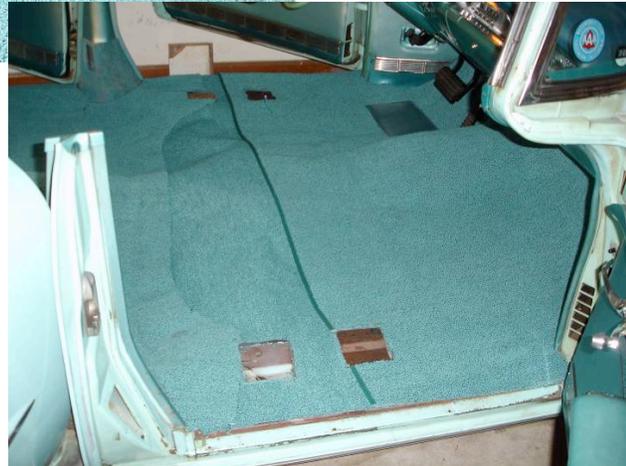
The rear carpet did not meet the front piece under the front seat and over at the sides near the doors. My solution? I ordered more carpet at \$89 from Stock Interiors to cover under the front seat over to the doors. It supplied enough extra for trim and for the trunk.

I had to have a shoe repair shop sew on vinyl edging (\$20 from Stock Interiors) for two small pieces fitted to the center door posts, down near the floor. (I glued this piece in instead of removing the old pieces from the posts; the old carpeting was sewn to the vinyl of the original.) While I was at it I had the shoe guy trim out the carpet for the trunk using the leftover edging. I polished and re-installed the door sills, careful not to cause the carpet to run as I inserted the screws.

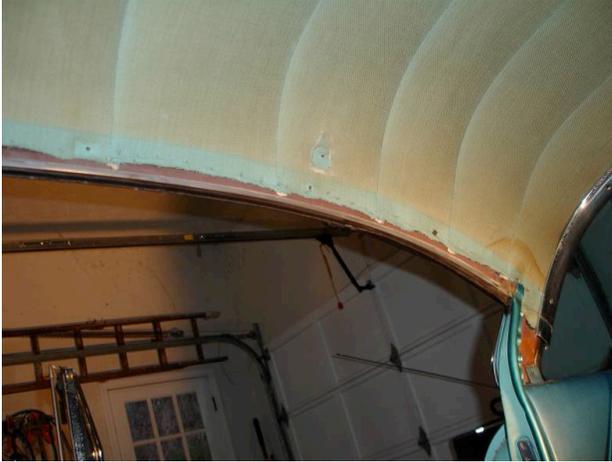
The headliner: I took a day just to look it over and to think about what I was about to do. For \$250 I had ordered a pre-sewn header from SMS Auto Fabrics of Canby, OR. This was a perfect match for the old material, down to the pattern in the fabric. (Stock Interiors could not match it.) You can see below how discolored the old header was, even though it was still intact. It took me about a day to remove all the interior brightwork, carefully tagging and bagging the pieces. What was left was a fiberboard tack strip that ran the perimeter of the compartment. Cadillac's builders used narrow 1/4"-long staples every quarter inch or so

to hold the liner at its edges. I pulled the liner away from the tack strip with a pair of needle-nose pliers. Most of the tack strip stayed in place, but I had to glue a few pieces back in. (I could not find a replacement for this strip, so I was lucky mine stayed in good shape.)

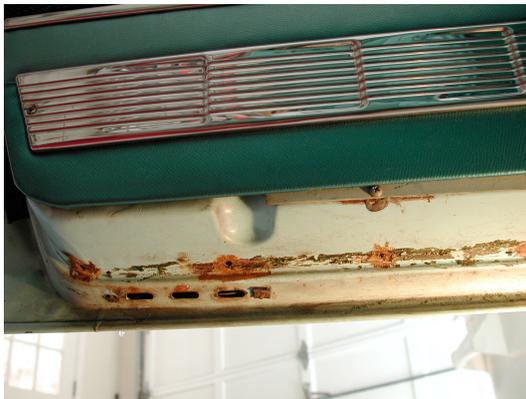
Next, I did the rear doors' weather stripping (\$122). The rubber was mostly fastened with wire tabs; only about four inches near the doors' locks were glued. But the lower edges of all the Turk's doors (below) were beginning to show some light rust around the holes

where the rubber seals are mounted. I took the time to wire bush the mounting holes with the Dremel, swabbed on and wiped off naval jelly to neutralize the rust, then sprayed on Rustoleum before installing the new rubber. It wasn't a great fix, but this is an unseen location and it may hold off the need for body repairs a little while longer.

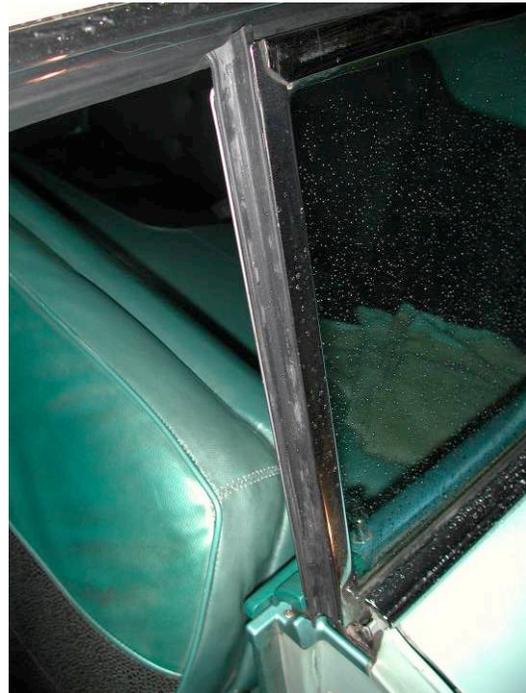
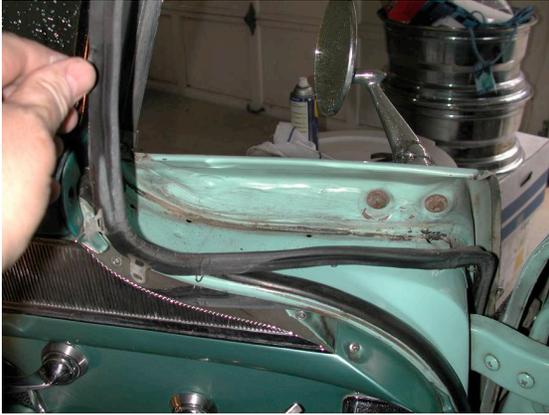
The front edges of the rear windows have seals that seat with the front windows. On the Turk these were hard, crispy and breaking away. I had replacement parts from SoffSeal (\$22/pair). The rubber has a metal strip embedded, and getting the old piece out of its slot was hard. The builders had crimped the slot with a hammer blow. The only way to reverse this was to destroy the old rubber by working the crimp with a screwdriver until it released the old fitting. I sprayed the new rubber insert with WD40 and it slid right back in. I'll re-crimp IF it ever slides downward. By the way, Steele's Lock Pillar Fillers (\$28) are the wrong parts for this car; so don't bother.

Finally, I replaced the long seals on the front doors (\$146). The old rubber comes off with a putty knife, and all surfaces are cleaned as before, including rust treatment for the lower edges of the doors. But the leading edge of the doors is hard to access for removing and re-installing the weather stripping – at least for big old hands like mine. You’ll need a long screwdriver. One more thing: The Steele products were too long by about two inches, which wouldn’t be a big issue except that both ends are finished. There are metal screw hold-
