# My HORNS Didn't Work! NOW they do!

By Doug Bailey

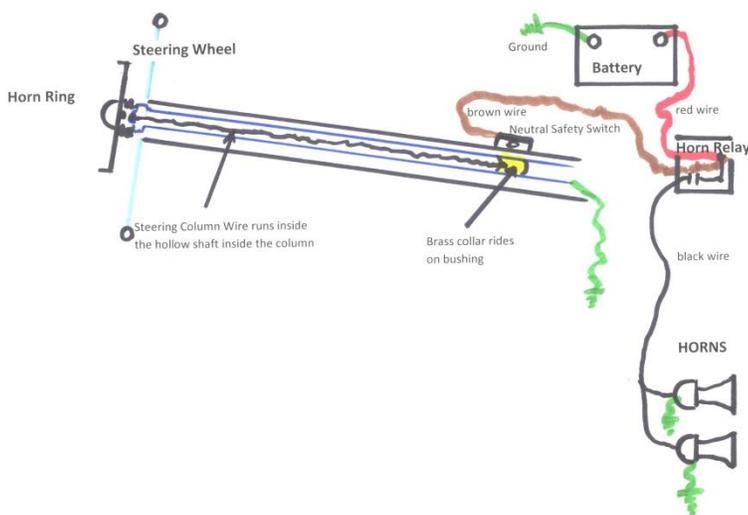
Horn Diagram: General Elements of the Horn in mid-Fifties Cadillacs

**Parts of the Horn System:** The general diagram below is redrawn from an article Dave Becker, the director of the 1958 Cadillac Owners' Online Group, sent me. It was originally developed by Kevin Rafferty for the Cascade Region of the CLC. It shows you the pieces of the horn circuit. These parts apply to about any Cadillac horns, but the rest of this article deals primarily with Fifties cars.

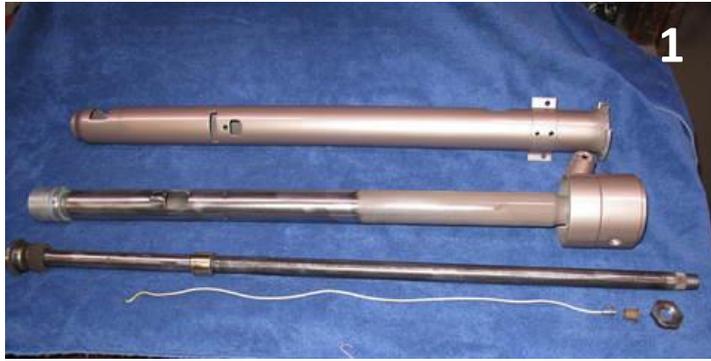
Photo #1 is a shot of the column from Chris Shaw's 1958 Cadillac (thanks Chris!). As you can see, three shafts make up the column. The bottom shaft rides inside the one in the middle, which rides in the housing at top. In this article I'm not tackling the turn signals or the steering coupler ("rag joint"). We will skip the center shaft in this photo and concentrate on the lower pieces in the shot.

**Steering Column Wire:** Look again at the parts at the top of the steering column (shown in the lower right corner of photo #1). The wire runs inside the shaft to a solder point on the brass collar down below. Notice that this wire has a brass nib soldered on at the top end. You can also see the shaft retaining nut, and a rubber "top hat" insulator. The wire runs down through that rubber insulator, which

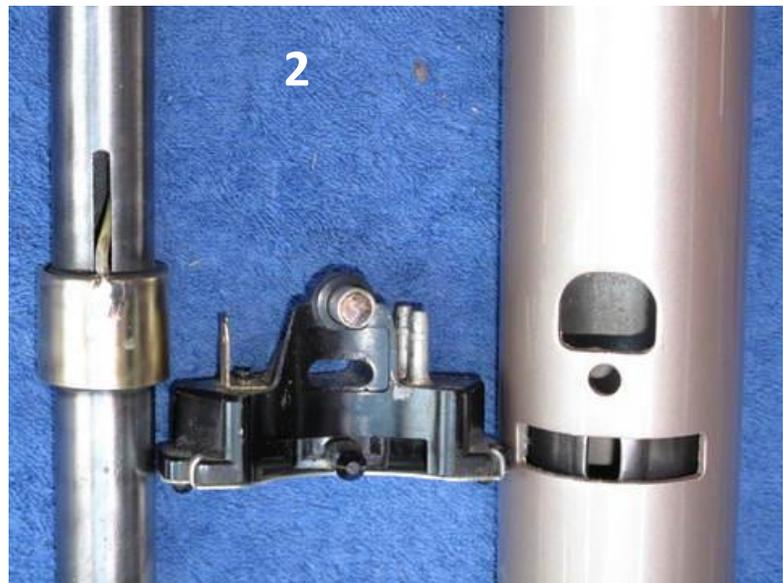
That's the NSS in the middle of photo #2, also supplied by Chris Shaw of the '58 Owners Group. On the right is the column, on the left is the hollow steel shaft that runs down inside the column. What might go wrong here? The housing of the NSS can break, because it's brittle plastic or Bakelite. A chip or a crack can loosen the button, losing contact. Normally the button rides on the brass collar shown beside the NSS, maintaining contact as the shaft rotates. In well-worn neutral safety switches, the button is worn smooth, even down to the metal retaining collar, like Chris's here.

To inspect the NSS, first disconnect the battery. (Do this while making *any* adjustments to your system.) Remove the NSS from the steering column, checking that the button is intact, spring-loaded, and not too worn down. Good luck finding a replacement NSS. They are out there, but they come dear. One on eBay right now lists for \$350! Peach State member Bob Winchell tells me the NSS can be rebuilt by "Chopper God," who's active on the '63-'64 Cadillac forum.

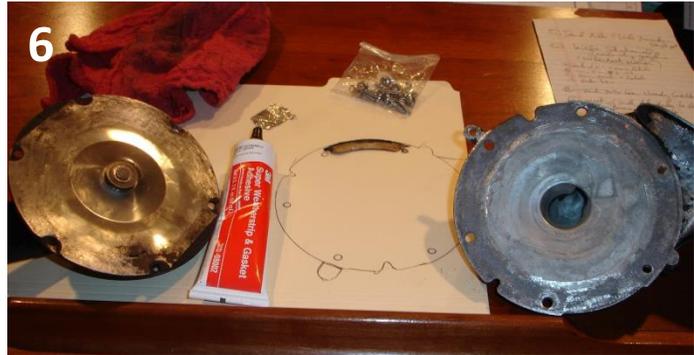
b. Photo #6 shows the two halves, separated and cleaned up before repainting the outsides "under hood" black. The left half (with the mounting bracket) holds the diaphragm. It's a metal version of a radio speaker's cone. That center post is a magnet. When the magnet is pulled by the electrical pulse, it vibrates the diaphragm, and gives us the sound. This shot shows the diaphragm after I've done my best to

polish off the rust and corrosion. If yours is too far gone, replace the horn. Mine worked, but rough edges will make your horn sound puny. Better to find one online.

a. Drill out the rivets holding the two halves of the horn housing together. Find some small bolts with lock washers to replace those rivets. You'll need them later.

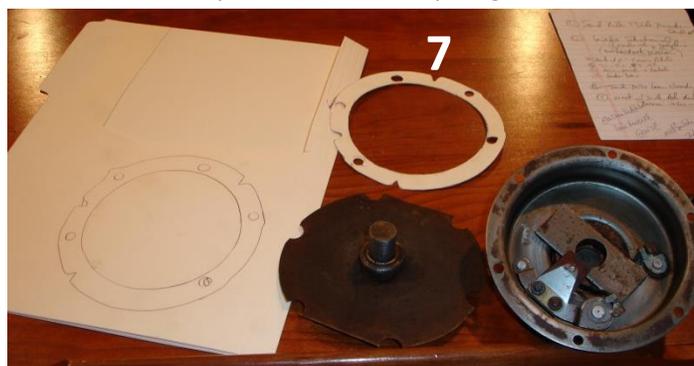
c. In photo #7 the bracketed half is apart (this is the left side in photo #6): The diaphragm is outside the housing, flipped over. Clean these parts up, inside and out. My diaphragm remained slightly corroded on this side, but this side won't matter. Treat it and move on. The edges must be clean enough to make a seal with the gasket (see next step). Also clean up the housing containing the circuitry. Check contacts and re-solder if necessary.

d. You need to replace the gaskets before re-assembly. A manila file folder works fine. Trace the outline of the horn's half onto the paper and then cut out *one for each side of the diaphragm*. Be precise! It will make a difference. I used the adhesive we use on rubber window seals, running a bead along both sides of each new gasket. Re-assemble the pieces of the "horn sandwich" using the replacement bolts and lock washers you found to fit. This can be tricky. If you allow the diaphragm to touch the horn housing it will not work. Same with the new bolts. Bench test your repair with a 12-volt battery. Good luck!
