Refreshing the Turk's Interior

by Doug Bailey, member '58 Cadillac Owners' Club (*right*)

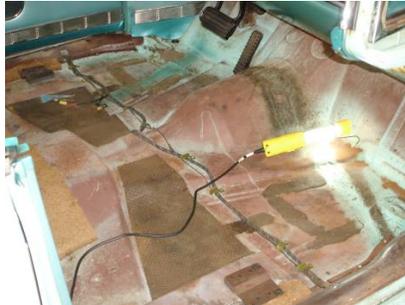
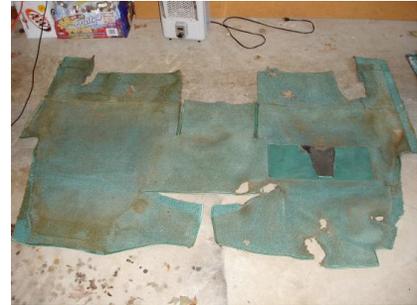
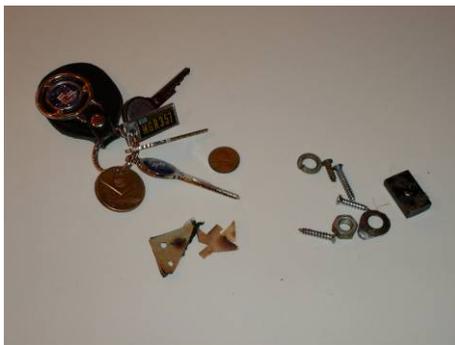
The carpet: I ordered the molded carpet replacement from Stock Interiors online (\$157, and two pads at \$50 each). With the seats out I spent a day removing the door sills and original carpet. It took a while to wire-brush the remaining horsehair padding from the floors, where it had been glued since 1957.

I expected to find a treasure trove of nearly fifty-year-old geegaws. Instead I found only a '64 penny, some screws, and a bunch of hairpins in the rear passenger-side corner, no doubt left from the original owner. Turk's paperwork says that had been Sylvia Goldstein, a patron of the musical arts in the LA area. She had ordered it delivered to LA in '58, then sold it to Wolf in 1962. I also found an original Cadillac medallion, which had been there from the beginning I suspect. That's it on the Joey Jesser key chain at left.

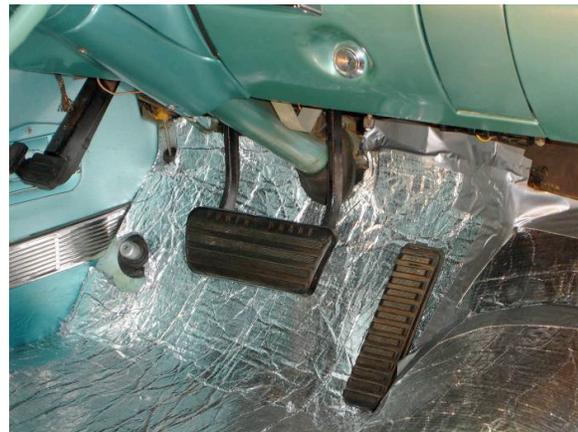
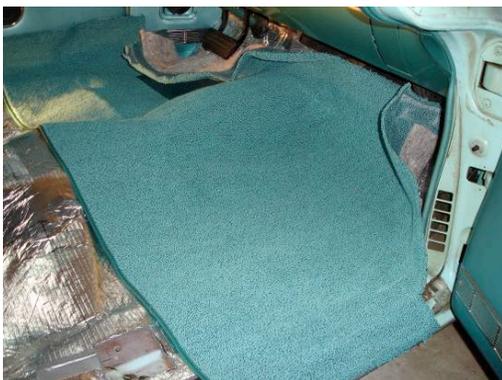
I inspected the floorboards for rust. Finding none I installed the new pad with scissors and duct tape. You know, it's not only great for hanging pictures and fixing the plumbing, it's great for the seams in a Cadillac's floor insulation! Next, the front carpeting. It's simply a trim and fit operation, using scissors and a razor knife and being careful not

to trim too much at a time. I worked from the center tunnel toward the back seat, then out to each side, duct-taping it to hold it as I worked. No glue! There are clips under the dash to clamp the leading edges. The toughest tasks? Locating the hole for the dimmer switch and working the carpet over the accelerator pedal.

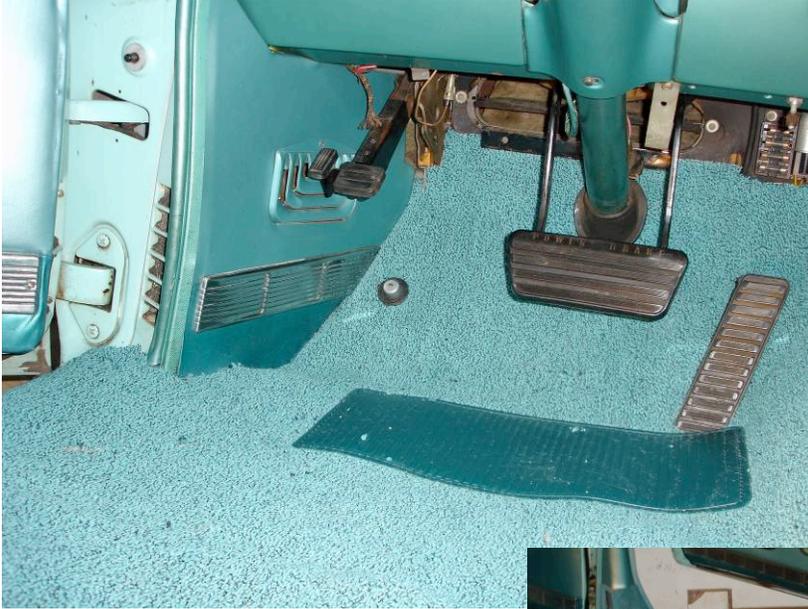
Installing the rear carpet was much harder because the molded piece was not well fitted to the deep wells of the rear floor. I had to cut in places I wish I had not, and I had to use spray-on upholstery glue in order for it to conform to the wells. Once I had the rear pieces in place I could see why Cadillac used separate pieces in the original install:

The rear carpet did not meet the front piece under the front seat and over at the sides near the doors. My solution? I ordered more carpet at \$89 from Stock Interiors to cover under the front seat over to the doors. It supplied enough extra for trim and for the trunk.

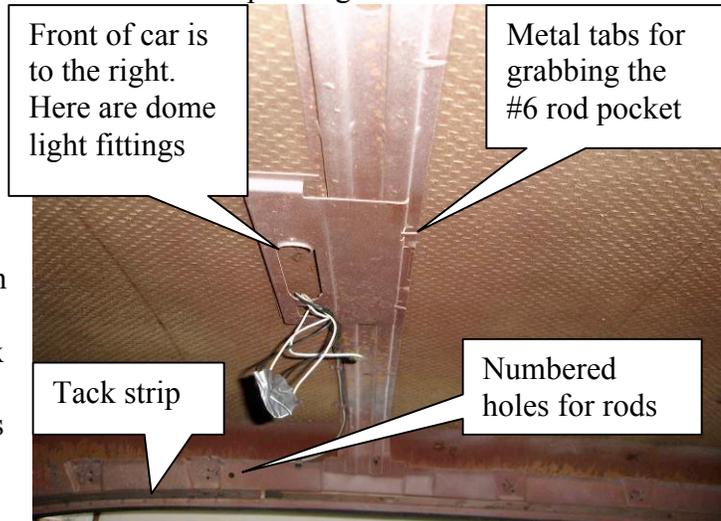
Installing the new liner: I learned that rod #6 is the key. You start there, in the middle! It has no hooks on its ends; it just fits into a slot in the roofing, and is held in place with six metal tabs that grab the #6 rod pocket. Once all the rods were in the pockets of the new headliner I measured the distance from the center line on the roof to the first tab-grabber on either side and transferred that measure to the #6 pocket on the liner. I then started by hanging #6, which is right behind the front seat and just ahead of the dome light. The entire liner can hang there from the two central tabs on #6, hanging down behind the front seat while you get the tabs hooked into the #6 pocket, grabbing the #6 rod. From there you work your way forward to #7, #8 and #9 – then backward to #5, #4, #3, #2 and #1. Be sure you are working with the liner centered on the rod, inserting each rod into its proper hole in the body. Each rod will start out flexed and out of vertical. Work them forward or back until they fit into place; mine sort of snapped into a proper slot. When all nine rods are in their holes you'll have the front and rear flaps hanging down, and the sides will all be loose, waiting for you to draw out the wrinkles and insert the staples.

First the wrinkles, which are caused by not being fully pulled down to the edges: You have to use a knife to reach up to each rod end and snip a notch into the rod pocket so that the liner can come down closer to where the rod rests in its hole in the body. Be careful! A slip

will cost you your \$250 investment. Work one rod at a time, both ends, and complete this step for all nine rods. When that's done go back over all nine again, snipping where you find wrinkles and pulling the liner down on the sides toward the rod's installation holes.

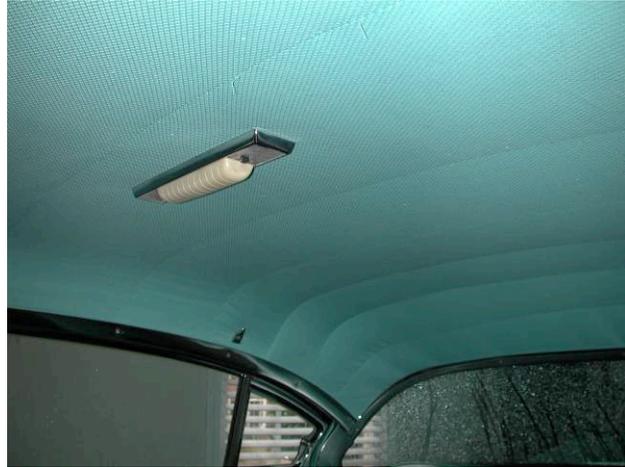
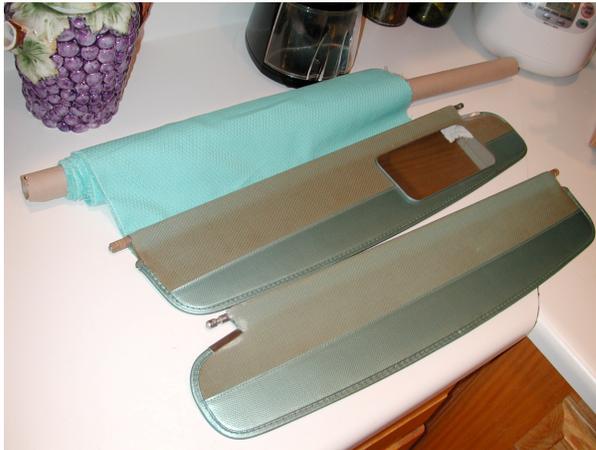
The sun visors: These are a challenge. The original pieces have a single swath of fabric wrapped around the fiberboard core, stitched along their margins to two pieces of matching vinyl, and all fitted to the visor with a vinyl edging – which is machine-sewn. The good news: SMS provided plenty of extra material from the headliner at no charge! The bad: I had to find someone who could do this complicated sewing with a heavy sewing machine. A home machine was not heavy-duty enough. I tried the shoe repair guy, but

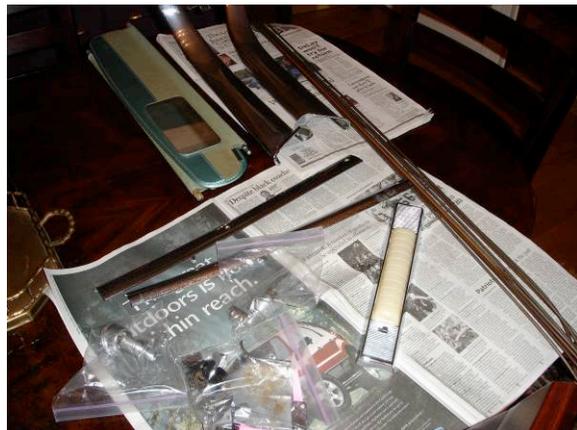
The interior brightwork: The overhead light has five wires: a ground and a positive and a negative for each of two lamps in the housing. Mine were fine without re-fitting the plugs. I screwed the trim pieces from the roof line, windshield and rear glass to boards to keep them from being bent or damaged as I worked on them. I decided not to have them polished or re-chromed profes-

sionally at this time. If I ever want to restore the Turk I can do that then. So, I just cleaned and polished as best I could, using soap and water, cleaning wax, a buffing wheel on a portable drill, a Dremel tool with a wire brush fitting, and fine-gauge steel wool. There was some pitting, but nothing a good re-chroming wouldn't cure one day. I tried to find new stainless or chrome screws, but no luck, so I just polished the old ones and re-used them.
